LANCASTER LANE RANCH

Historic Resource Report

August, 2007

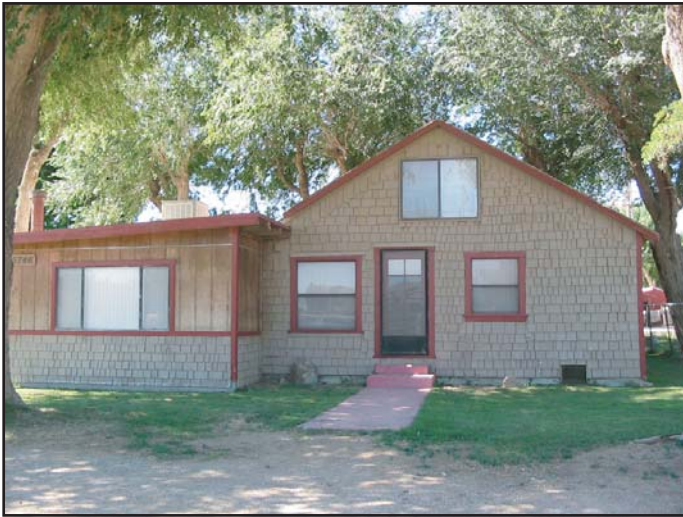
The small house is located near the driveway (see View 1). Mature trees are symmetrically arranged around the house. The house is composed of a main, two-story volume, and a one-story addition to the side. The older main portion of the house features a gabled roof and a shingled exterior. In contrast, the one-story portion is an obvious later addition, and is covered by a flat-roof with a wide overhang, and a wood paneled exterior. The house lacks a clear primary façade, as both the one-story addition and the two-story shingled portions contain front doors. An eight-paneled door is situated asymmetrically on the street-facing façade of the original portion, and flanked by two windows. The door on the addition is of modern construction, and a large horizontally-sliding window is arranged to the right of the door. A chimney is visible on the roof of the addition. The house contains virtually no architectural details, except for the shingled exterior. In addition to the one-story addition, all of the windows have been replaced.

View 1: View of the small house. Note the shingled facade, non-original windows, and one-story addition.

However, the subject building is not particularly intact, and is not part of a historic district. The integrity of the building has been comprised by the replacement of all of the windows, and most dramatically by the one-story addition to the side. This addition compromised the original scale of the house, as it nearly doubled the building footprint. Whatever original architectural character the house once had has been lost due to these alterations. The building is not considered an example of any distinctive type, period, or method of construction, much less an embodiment of these characteristics, and would therefore not be eligible for listing under Criterion C.

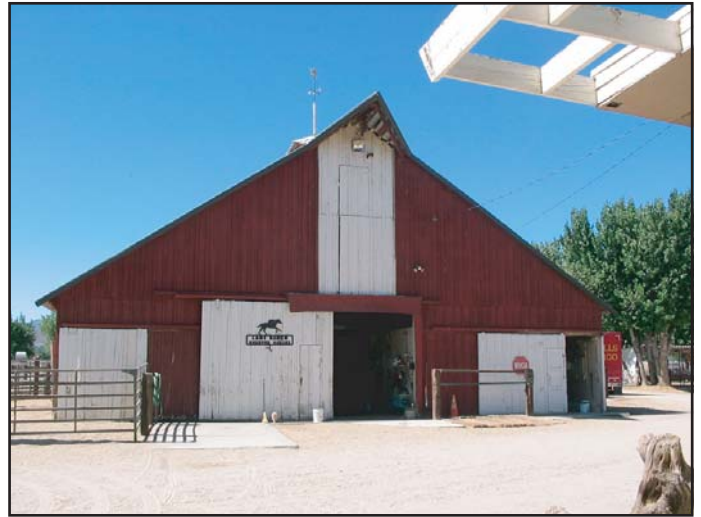
The barn is located in the center of the project site (see View 2). The barn is characterized by its steeply gabled roof, rectangular shape, and oversized sliding doors. The front façade of the barn is oriented toward Avenue L, although the barn is not visible from the street. The board-and-batten exterior includes a center plank sliding door, and two smaller sliding doors on either side. Above the center entrance on the level of the hayloft are two small slab doors. A roof overhang accentuates the apex of the roofline. The roof material itself appears to be new. A conversation with the current owner confirmed that he replaced the original shake roof. A ventilator lantern is located in the center of the gable, with a weathervane attached. The roof is so steeply pitched that the facades along the sides of the barn are one-story. These facades are plain except for sliding doors on either side. The rear façade contains a one-story lean-to, and two small windows. The interior of the barn has been altered. It was originally designed as a hay barn and was converted to a horse barn. In so doing, the original dirt floor was covered with concrete and horse stalls, doors, and partitions were added. The upper interior space is marked by the exposed wood beam truss system.

View 2: View of the barn. Note the steep gable roof, board-and-batten façade and the oversized sliding doors.

While the small shed associated with the barn is substantially intact, the subject barn has been significantly altered. The original shake roof has been replaced by a modern, metal roof. As noted above, window openings have been made on the rear façade of the barn. Historically, the barn was used as a hay barn, but the interior of the barn has been remodeled into a horse barn. The original dirt floor has been paved with cement, and stalls for horses and associated activities have been constructed in the barn. While the wood-frame barn and shed are intact and are good examples of agricultural architecture, the alterations to the main barn diminish the architectural integrity of both buildings. The two defining characteristics of the barn (the roof and the interior division of space) have been completely altered and no longer reflect the original construction. Therefore, the barn would not be eligible as “the embodiment of a style”.

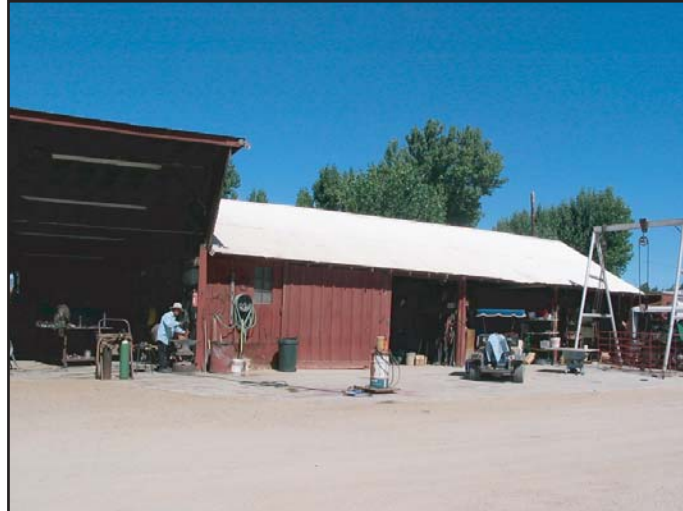
A board-and-batten shed is located directly behind the barn (see View 3). It functions as a garage and includes a small rectangular enclosed building, and sheds on either side. The shed portions contain three walls and a roof, but are open on one side. The board-and-batten façade of the building includes a small six-pane casement window that appears original. The shed features multiple corrugated metal rooflines, as one of the shed portions of the building is approximately two stories in height, while the rest of the building is approximately one story in height. Due to the board-and-batten façade and the corrugated metal roof, and its proximity to the barn, the subject shed appears to be from the same era as the barn.

View 3: View of the shed. Note the features of the garage are similar to those of the barn.

The associated shed is a fairly common example of a vernacular agricultural outbuilding. As stated above, a vernacular building would have to be particularly well-intact, or a part of a historic district in order to be eligible under Criterion C. However, the subject building is not part of a historic district, and is not particularly intact. The shed includes a cement slab floor instead of a dirt floor, and is used to store equipment for the Lane Ranch and Cattle Company, a contemporary supply company. The building is plain and unremarkable, and would not be considered eligible under Criterion C.

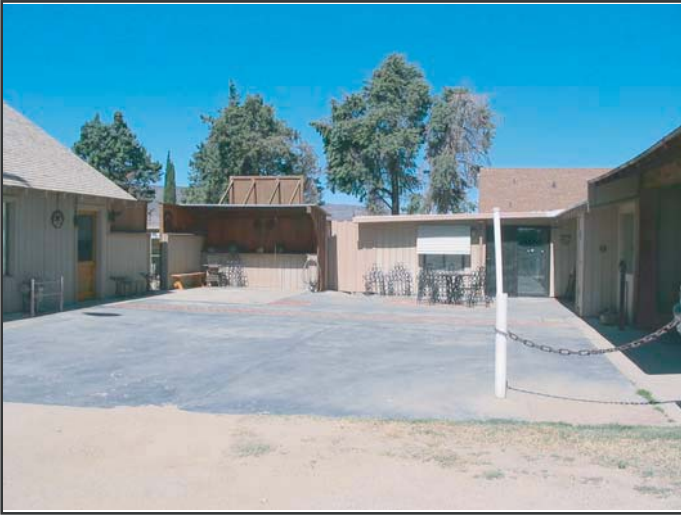
View 4: View of the area south of the main house, including various service buildings.

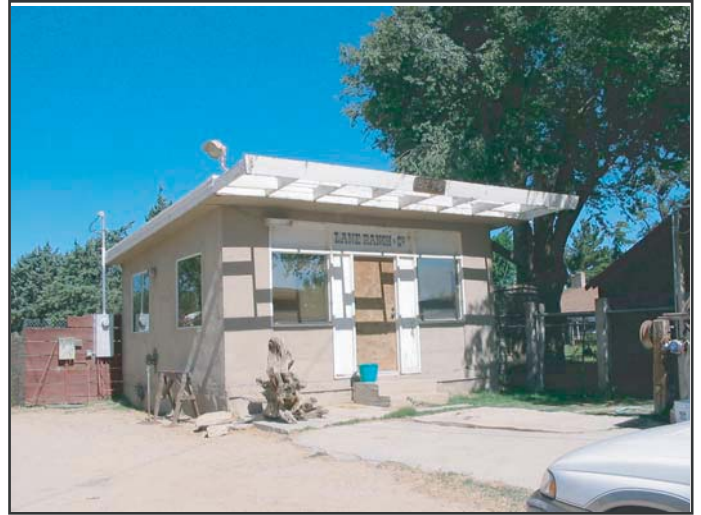
View 5: View of one of the service/office buildings of relatively modern construction. Note the unremarkable architectural character.

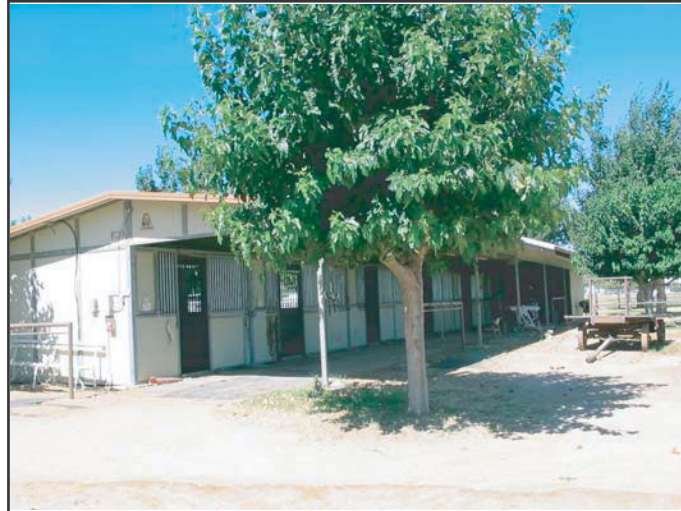
View 6: View of a service outbuilding.

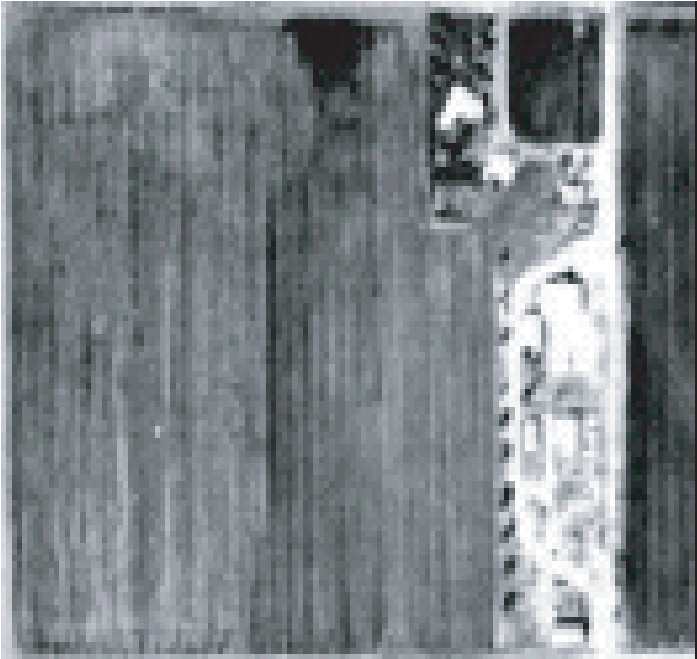
1953 Aerial

The Lane family lived in the small house and worked on the farm growing alfalfa, similar to other Lancaster residents. The 1953 aerial photograph (see Figure I) shows that the property was still used for agricultural purposes at this time. The buildings are clustered on the far eastern portion of the property, and the rest of the property is clearly plowed for agricultural purposes. The barn and smaller residence is visible in the aerial. There are other agricultural buildings visible on the 1953 aerial, but they do not appear to be the same buildings currently on the property due to differences in building footprints. The 1968 aerial photograph shows the addition of several other structures, including buildings on the western portion of the project site, along Avenue L. The quality of the 1968 aerial is very poor, and the detail of the buildings is not visible. By the time the 1989 aerial photograph was taken, the property had been converted to its present use. The "Lane Ranch and Cattle Company" supplies agricultural equipment and livestock to the entertainment business. Many of the older structures associated with the agricultural use of the property were removed, while others that support the current use were added. The 1994 and 2002 aerials show the property much as it was in 1989.

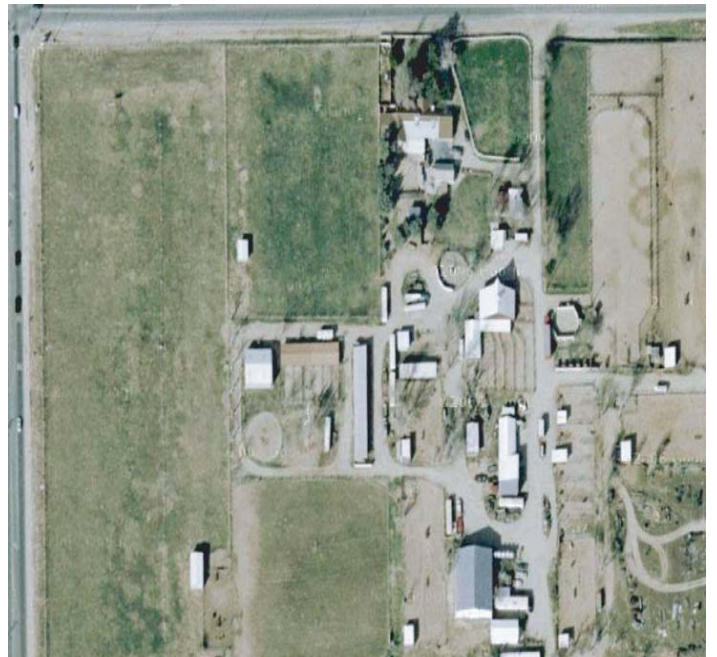
Current Aerial

Source: Environmental Data Resources, The EDR Aerial Photo Decades Package, 60th Street West Lancaster, June 4, 2007 and Google 2007.

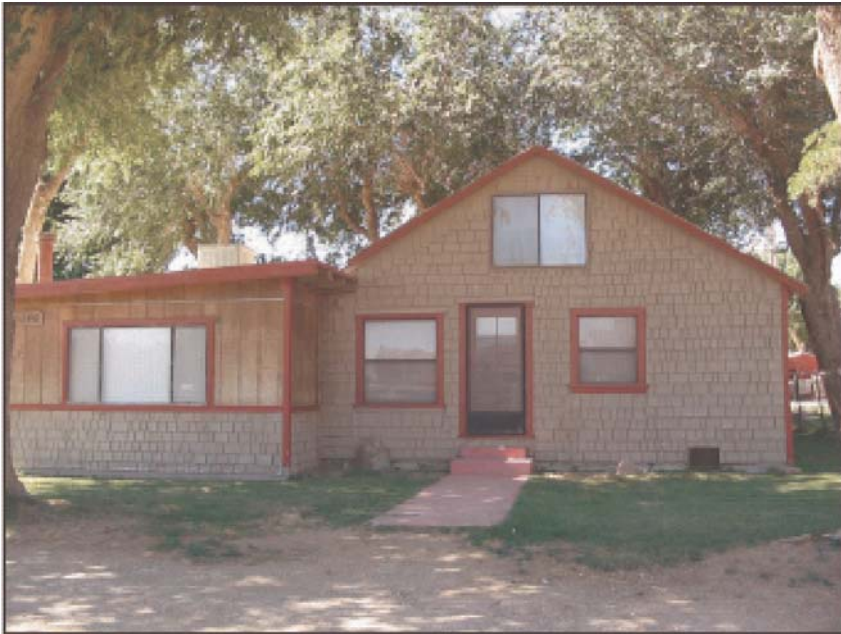
View of facade facing Avenue L. July 2007

- B1. Historic Name: *N/A*
- B2. Common Name: *Small House at Lane Ranch*
- B3. Original Use: *Residence*
- B4. Present Use: *Residence*
- *B5. Architectural Style: *Vernacular*
- *B6. Construction History: (Construction date, alterations, and date of alterations)
Moved from original location. One-story addition. All windows have been replaced.

The building is not particularly intact, and is not part of a historic district. The integrity of the building has been comprised by the replacement of all of the windows, and most dramatically by the one-story addition to the side of the original portion of the house. This addition compromised the original scale of the house, as it nearly doubled the building footprint. Whatever original architectural character the house once had has been lost due to these alterations. The building is not considered an example of any distinctive type, period, or method of construction, much less an embodiment of these characteristics. Further, the building is not associated with an event or person of historical significance.

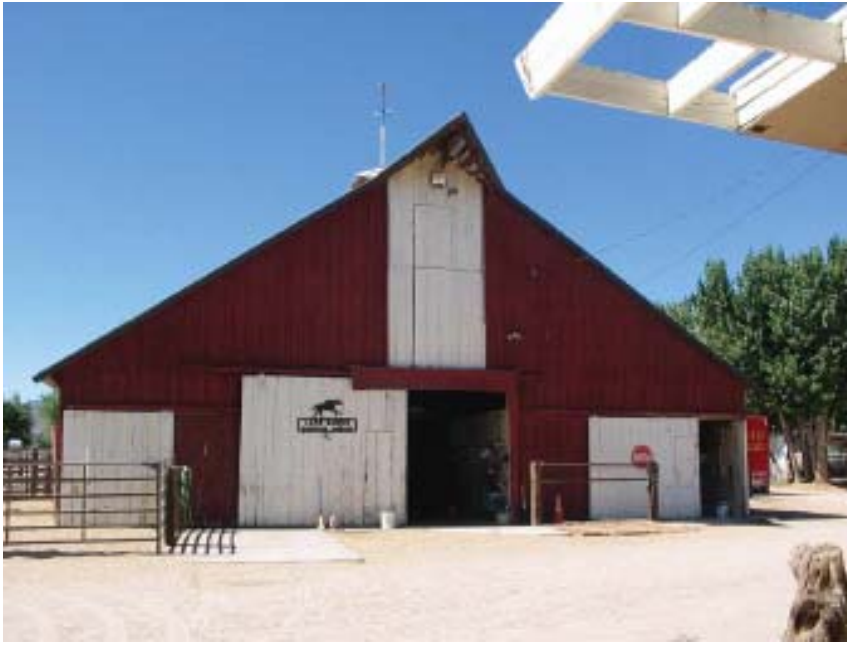
View of front facade, July 2007.

Moved from original location. Shake roof replaced by modern material. Dirt floor paved with cement. Interior partitions added to accommodate horses, hayloft altered, rear windows added.

The barn has been significantly altered. The original shake roof has been replaced by a modern, metal roof. As noted above, window openings have been made on the rear façade of the barn. Historically, the barn was used as a hay barn, but the interior of the barn has been remodeled into a horse barn. The original dirt floor has been paved with cement, and stalls for horses and associated activities have been constructed in the barn. While the barn is an older example of agricultural architecture in Lancaster, the alterations render it ineligible for consideration as "the embodiment of a style". Two of the defining characteristics of the barn (the roof and the interior division of space) have been completely altered and no longer reflect the original construction. Further, the building is not associated with an event or person of historical significance.

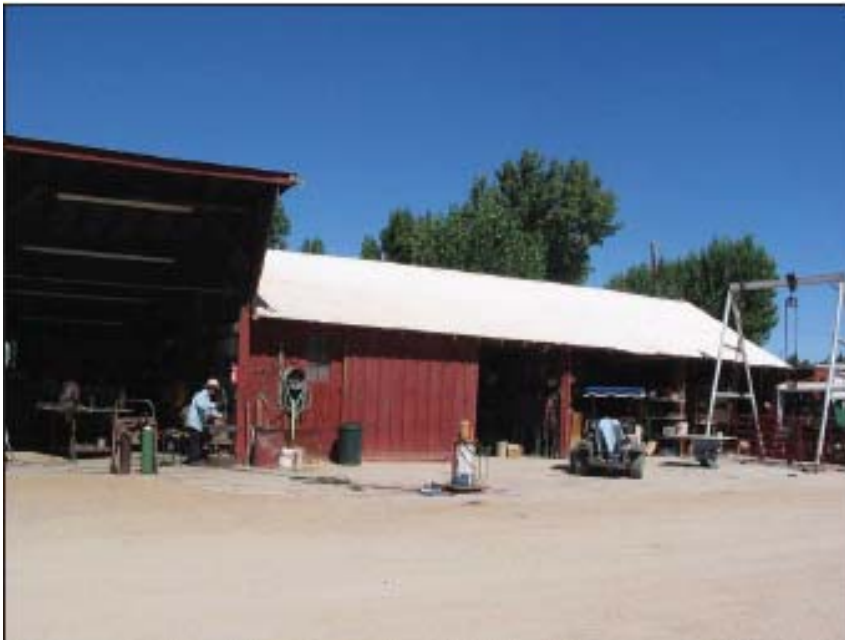
P5a. Photograph or Drawing (Photograph required for buildings, structures, and objects.)

View of front facade, July 2007.
