SEWER COLLECTION SYSTEM ANNUAL REPORT

2019/2020

City of Lancaster

A report of the history, current assessment, budget, activities, and the achievements of the Lancaster, California Sewer Collection System in Fiscal Year 2019/2020.

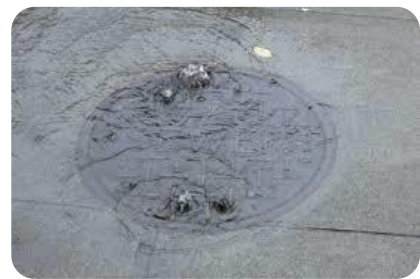
Cleaning consists of pipe flushing and root removal. Field staff cleans system pipes regularly using a hydrojet, a high-pressure jetting system which utilizes water and an optional vacuum to remove debris. This removes grease buildup as well as minor roots and debris to enable the wastewater to flow freely through the pipes. Blocked wastewater causes odors, SSOs, and damage to pipes. The objective of sewer pipe cleaning is to prevent future blockages of the sewer system. Roots are also removed by a mechanical cutting rodder or treated with environmentally safe foam. The majority of the maintenance budget is spent on these procedures.

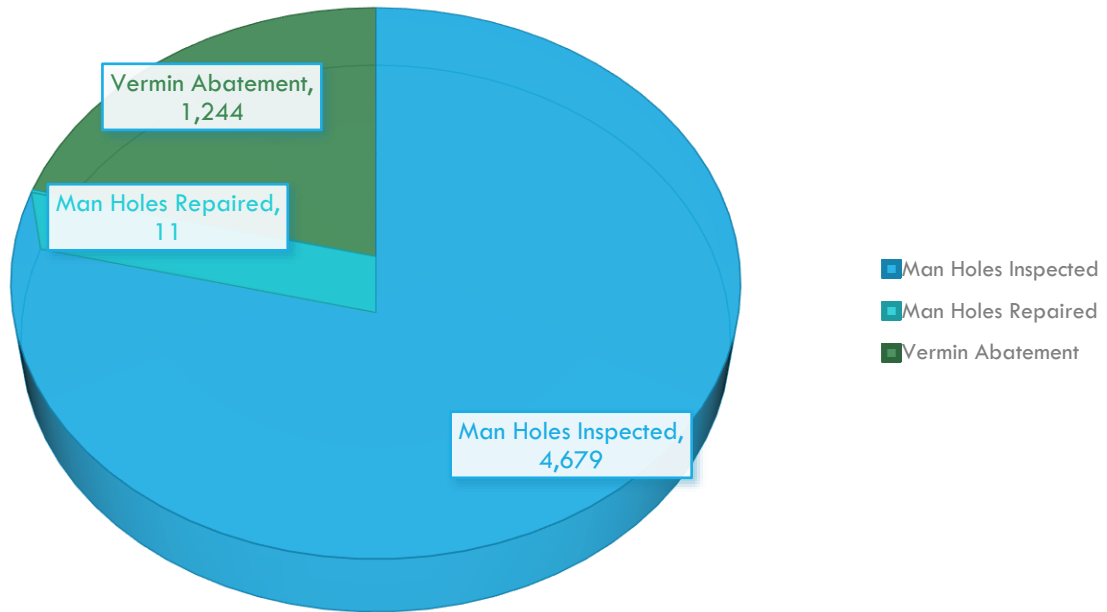
MAN HOLE ACTIVITY

2019/2020 Annual Sewer Maintenance Activity at a Glance
